Project ID: 22PAR458

## PROJECT NAME: Sewer Manholes Repairs and Restorations

PROJECT LOCATION: Dinosaur Provincial Park

### End of Project Report

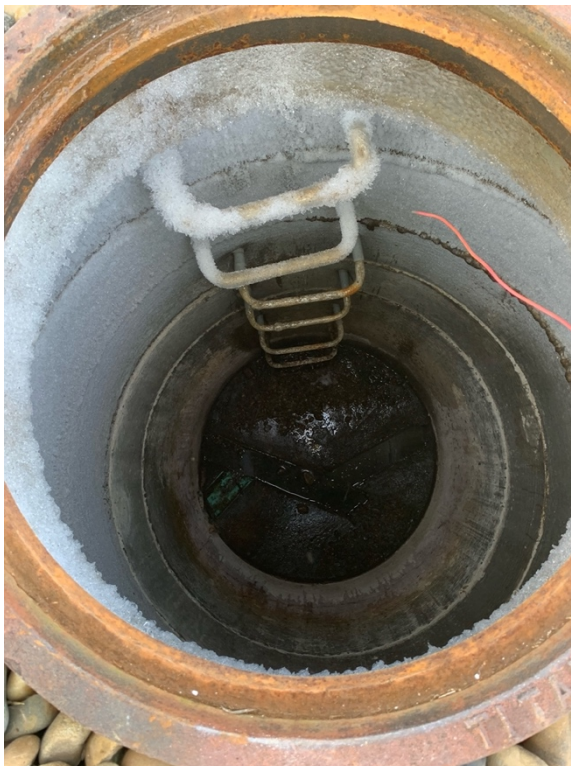
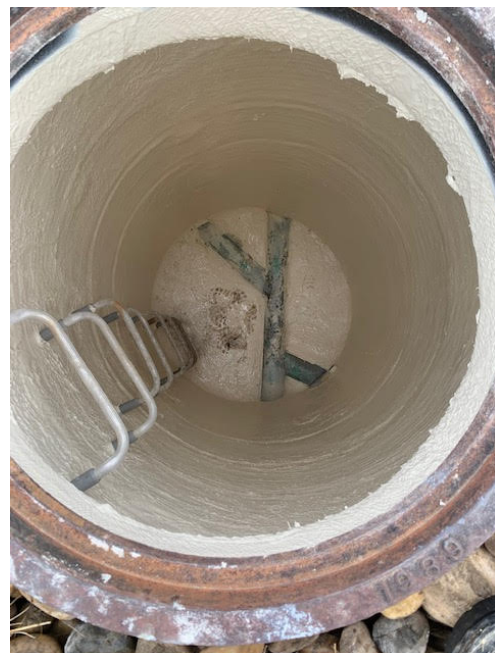
Coated:

Identification of Manhole: <b>3a</b>	
Date that the manhole was grouted and sealed:	January 26, 2022
Manhole Depth (m):	4,267mm
Manhole Diameter (mm):	1,219mm
The type of grout used to seal each manhole:	Quick Set Mortar Mix
Volume of any additive (s) used:	Speed Plug-Hydraulic grout. As needed to stop infiltration.
The volume of each grouting material used to seal:	1 bag
Grout gel time in seconds:	10sec
Additional Notes:	Standard Mortar Repair. Removed 15-20 gal of rocks. Rocks were removed as far as our tools could reach in discharge lines. Recommend getting inspected.

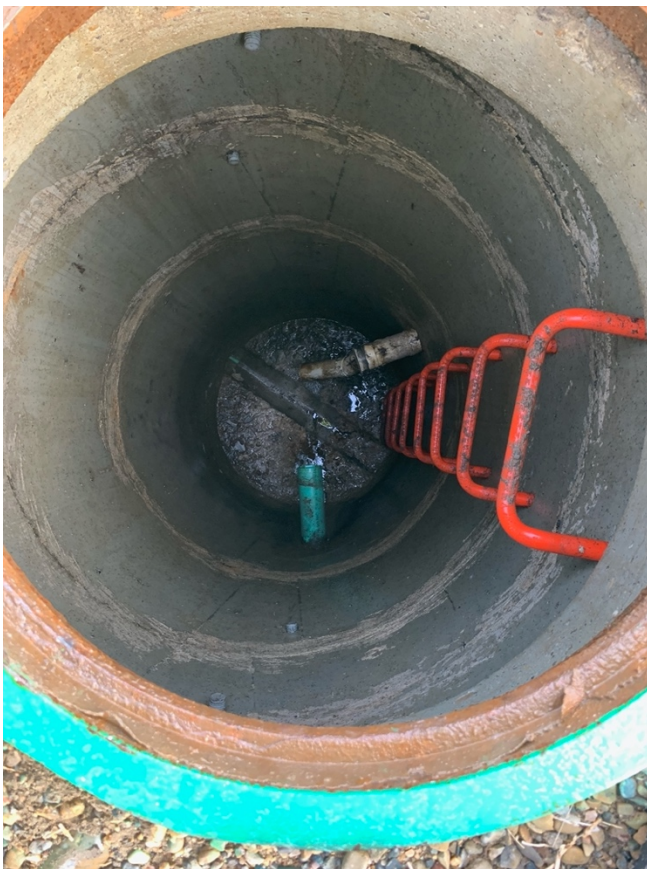
Before:

Identification of Manhole: <b>3b</b>	
Date that the manhole was grouted and sealed:	January 27, 2022
Manhole Depth (m):	3,358mm
Manhole Diameter (mm):	1,219mm
The type of grout used to seal each manhole:	Quick Set Mortar Mix
Volume of any additive (s) used:	Speed Plug-Hydraulic grout. As needed to stop infiltration.
The volume of each grouting material used to seal:	1 bag
Grout gel time in seconds:	10sec
Additional Notes:	Standard Mortar Repair

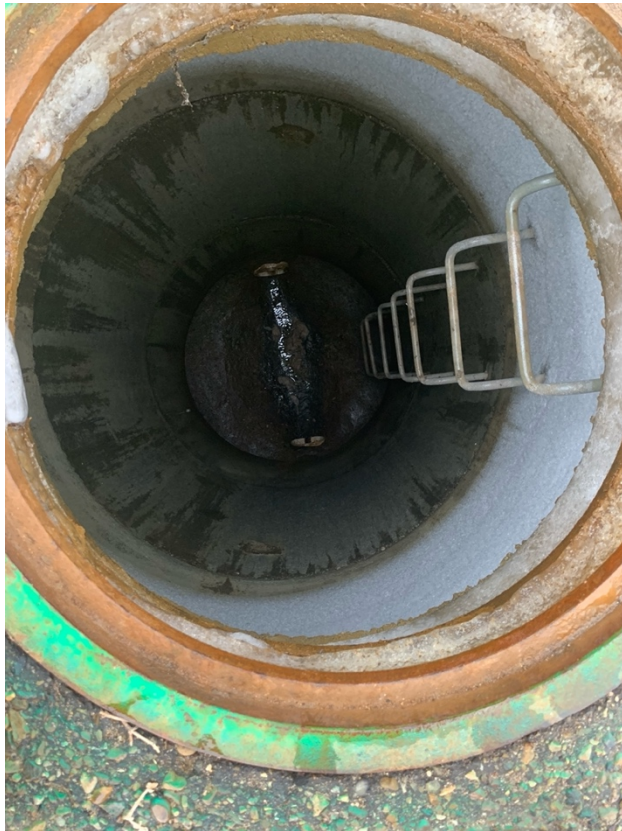
Before:

Identification of Manhole: <b>3c</b>	
Date that the manhole was grouted and sealed:	January 22, 2022
Manhole Depth (m):	3,353mm
Manhole Diameter (mm):	1219mm
The type of grout used to seal each manhole:	Quick Set Mortar Mix
Volume of any additive (s) used:	Speed Plug-Hydraulic grout. As needed to stop infiltration.
The volume of each grouting material used to seal:	2 bags
Grout gel time in seconds:	10sec
Additional Notes:	Standard Mortar Repairs

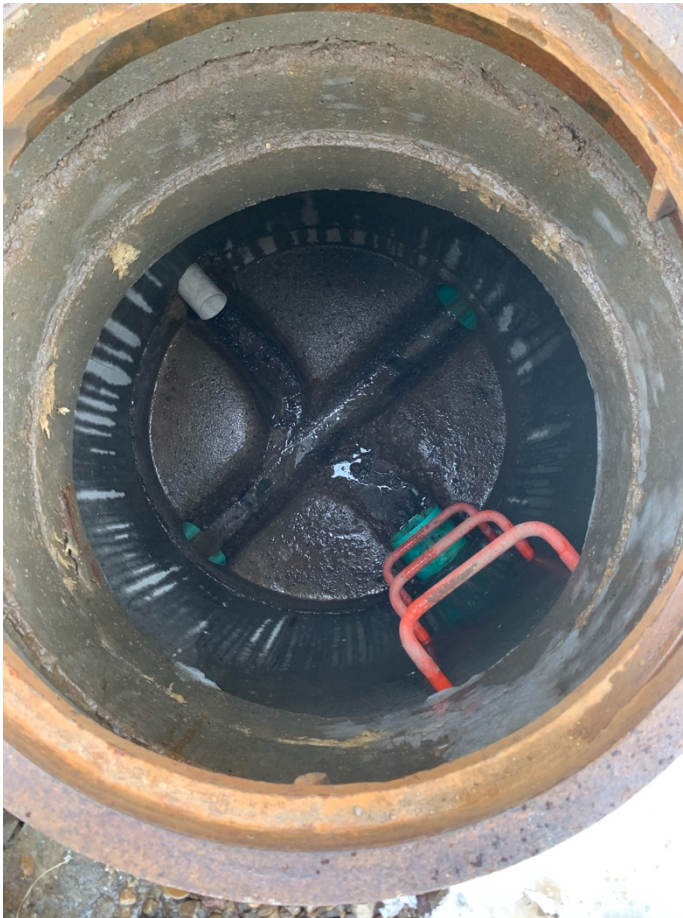
Before:

Identification of Manhole: <b>3d-1</b>	
Date that the manhole was grouted and sealed:	January 20, 2022
Manhole Depth (m):	1,829mm
Manhole Diameter (mm):	1,219mm
The type of grout used to seal each manhole:	Quick Set Mortar Mix
Volume of any additive (s) used:	Speed Plug-Hydraulic grout. As needed to stop infiltration.
The volume of each grouting material used to seal:	1 bag
Grout gel time in seconds:	10sec
Additional Notes:	Standard Mortar Repairs

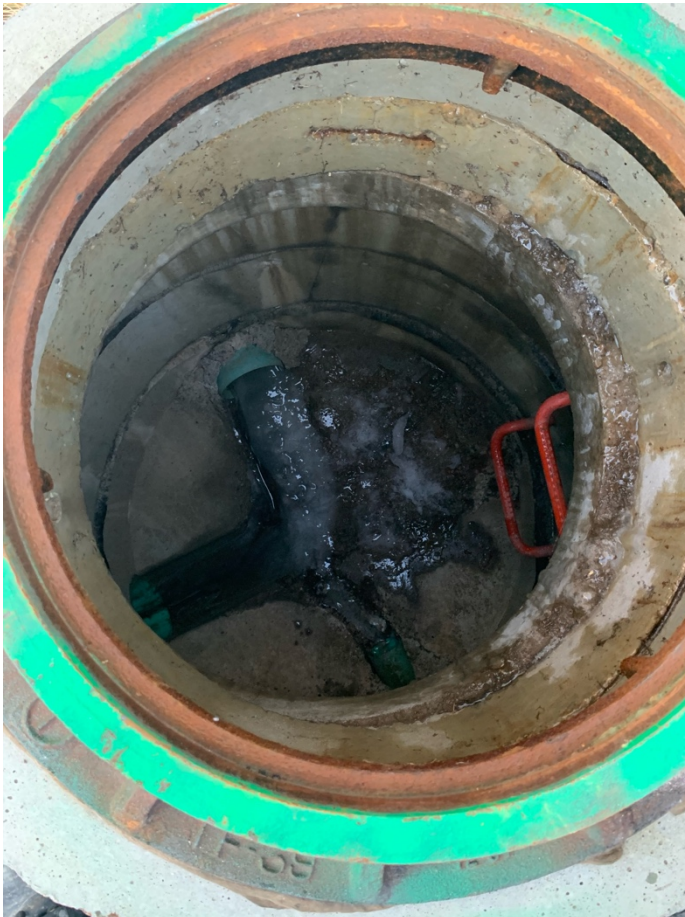
Before:

Identification of Manhole: <b>3d-2</b>	
Date that the manhole was grouted and sealed:	January 21, 2022
Manhole Depth (m):	1,829mm
Manhole Diameter (mm):	1,219mm
The type of grout used to seal each manhole:	Quick Set Mortar Mix
Volume of any additive (s) used:	Speed Plug-Hydraulic grout. As needed to stop infiltration.
The volume of each grouting material used to seal:	1 bag
Grout gel time in seconds:	10sec
Additional Notes:	Standard Mortar Repairs

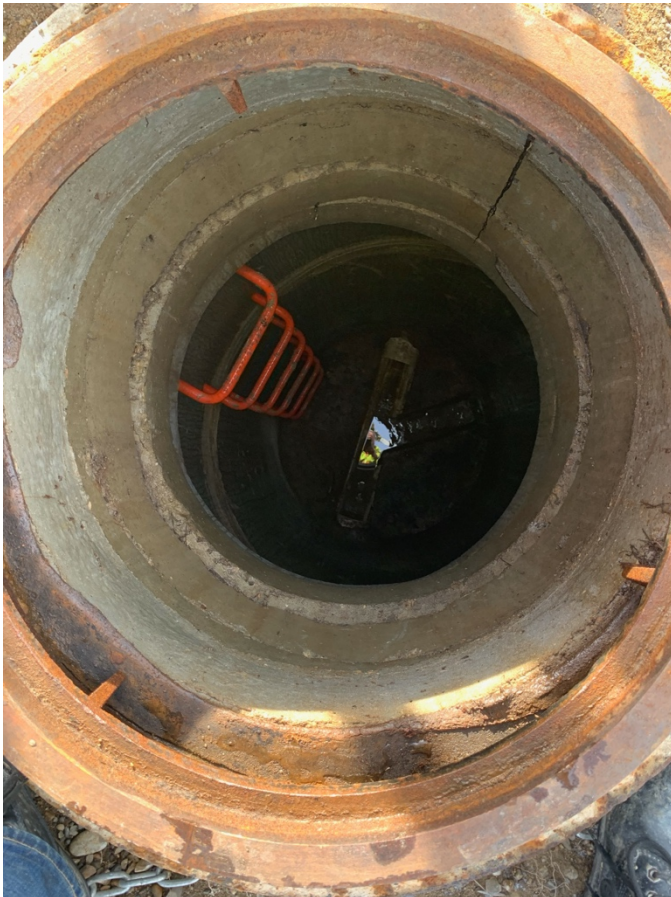
Before:

Identification of Manhole: <b>3e</b>	
Date that the manhole was grouted and sealed:	January 28, 2022
Manhole Depth (m):	3,358mm
Manhole Diameter (mm):	1,219mm
The type of grout used to seal each manhole:	Quick Set Mortar Mix
Volume of any additive (s) used:	Speed Plug-Hydraulic grout. As needed to stop infiltration.
The volume of each grouting material used to seal:	3 bags
Grout gel time in seconds:	10sec
Additional Notes:	Standard Mortar Repairs. Rebuilt Bench. Cover ring loose.

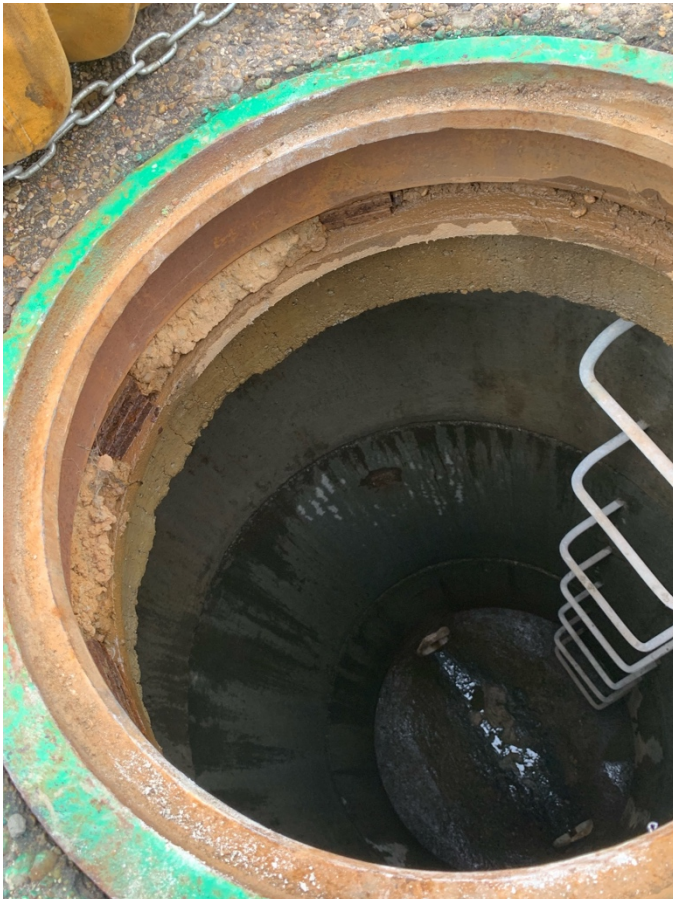
Before:

Identification of Manhole: <b>3f</b>	
Date that the manhole was grouted and sealed:	January 25,2011
Manhole Depth (m):	3,358mm
Manhole Diameter (mm):	1,219mm
The type of grout used to seal each manhole:	Quick Set Mortar Mix
Volume of any additive (s) used:	Speed Plug-Hydraulic grout. As needed to stop infiltration.
The volume of each grouting material used to seal:	2 bags
Grout gel time in seconds:	10sec
Additional Notes:	Standard Mortar Repairs. Rebuilt bench
